TAMPA YACHT & COUNTRY CLUB

Turrell, Hall & Associates, Inc.

2015 - 2017 Marina Improvements & Reconstruction

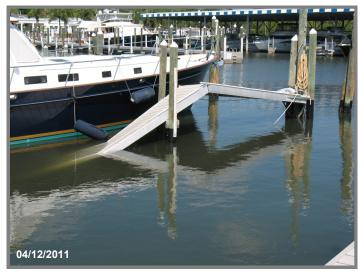
Tornado damage in 2011.

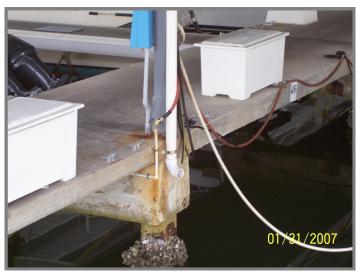
Concrete support cap, cracked and deteriorating.

> This work led to the conclusion that the entire marina was in jeopardy and should be reconstructed. In engineering terms the docks, roofs, seawalls and structures supporting the breakwater had reached the end of their design life - it was time to rebuild.

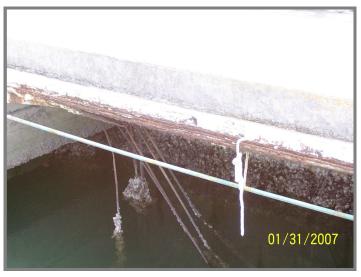
Existing seawall showing reinforcement steel.

A new **seawall** was designed for the entire interior of the basin. Vinyl seawall was chosen for the portion that interfaces with sea water to reduce corrosion, while a traditional concrete cap was customized to accommodate the new walkway pavers along the waterfront.

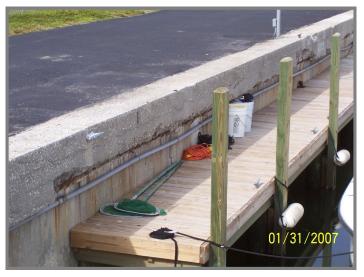
Deteriorated seawall showing cracks and exposed rebar.

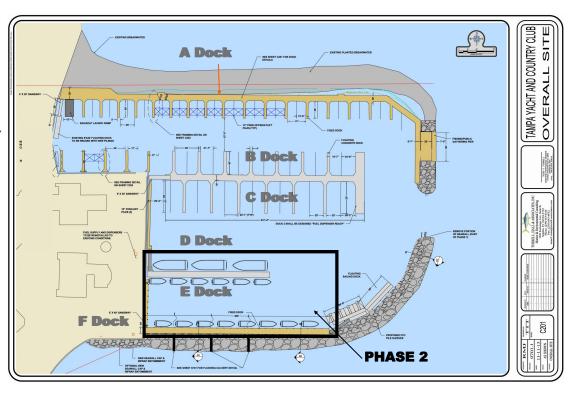
Phase 2 replaced the existing fuel dock, constructed a concrete floating pier for D & E Dock, and created an IPE decked dock with a floating system for F Dock.

The future **Build-out** phase will add finger piers to D and E Dock and complete the IPE decked structure on F Dock

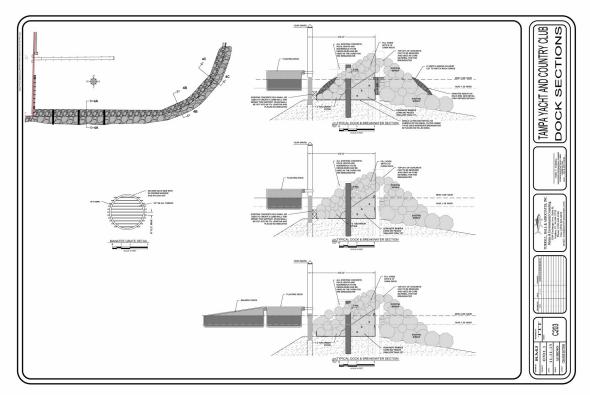
Typical breakwater plan.

The rock **breakwater** was designed to be left intact on the seaward side to maintain its strength. The old concrete decks and seawall cap on the inside were broken up and entombed in new rock to create a clean, natural look.

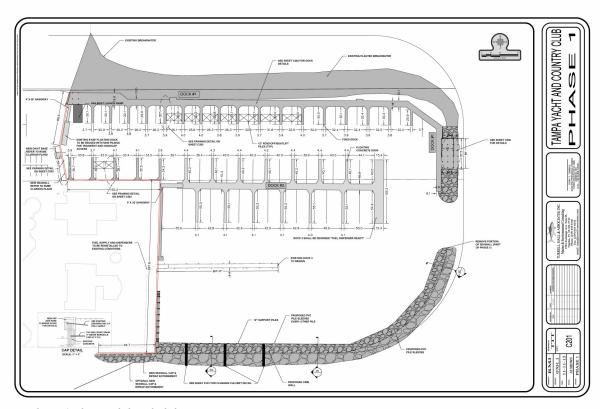
Phase 1 has been built within the confines of the existing yacht basin with new IPE decked docks, a gazebo platform and boat lifts on A Dock, and a new concrete floating system for B and C Dock.

Phase 1 plan and detailed dimensions.

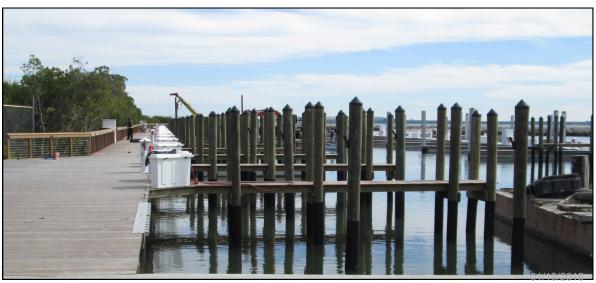
Wooden fixed docks with IPE (hardwood) decking were used around the perimeter of the marina so a highend finish could be obtained at a reasonable cost. The wood piling will last for decades, as they are wrapped with PVC to prevent damage from marine organisms which would otherwise destroy the wood over time.

New piling supported structure with IPE decking.

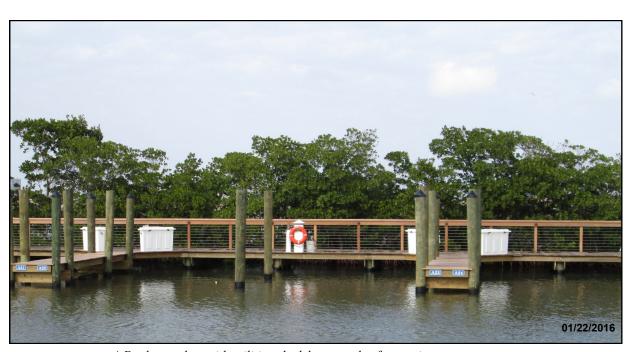
A Dock complete with utilities, dock boxes and safety equipment.

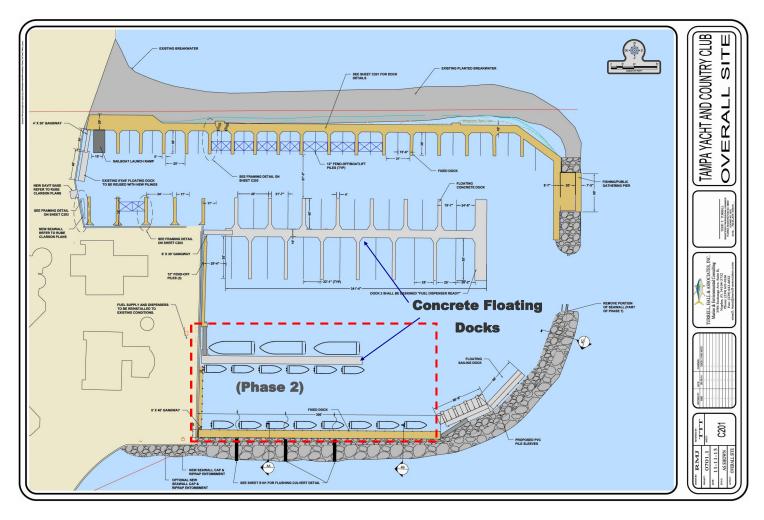
Concrete floating docks were selected for the middle two sections of the project due to their stability, easy access and long service life. These docks are state-of-the-art in the industry for high end yacht marinas.

New concrete floating docks in place.

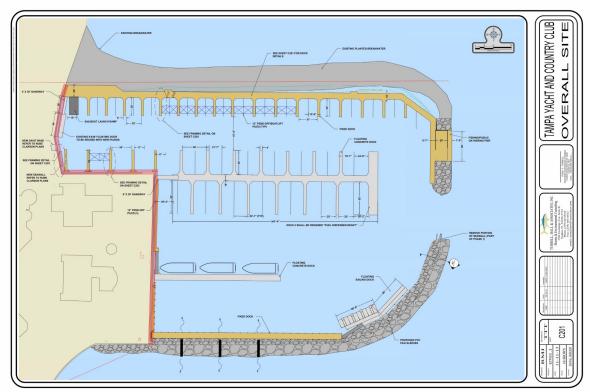
Seawall area highlighted in red.

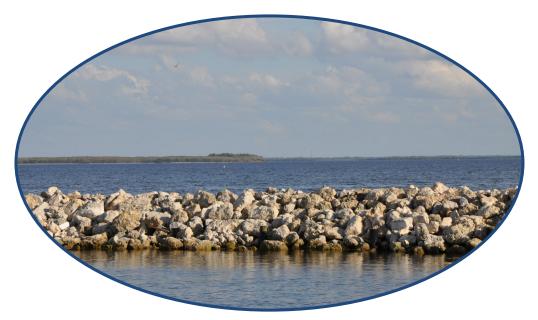
New breakwater in place.

The breakwater was penetrated in three places with pipes allowing water to flow in and out of the yacht basin, thus improving water quality in the marina.

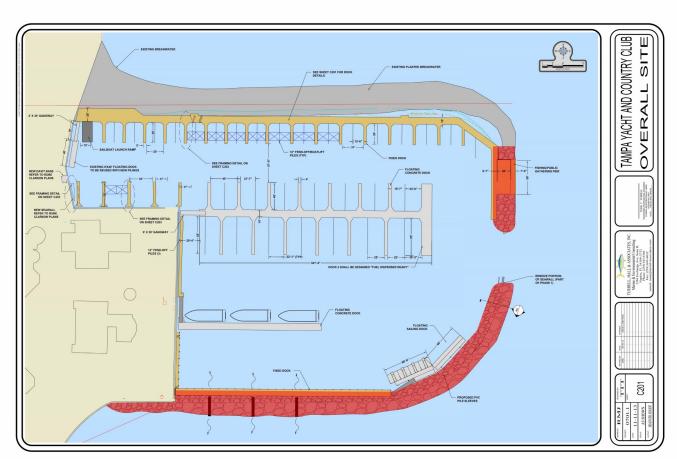
Breakwater highlighted in red.

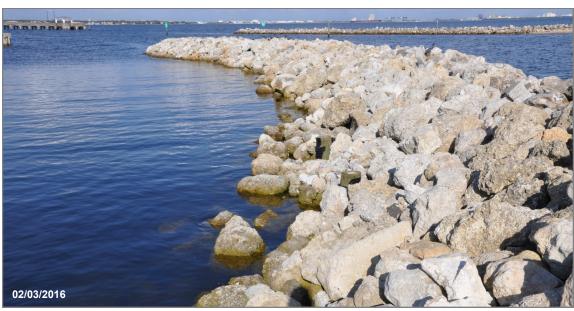
Finished breakwater.

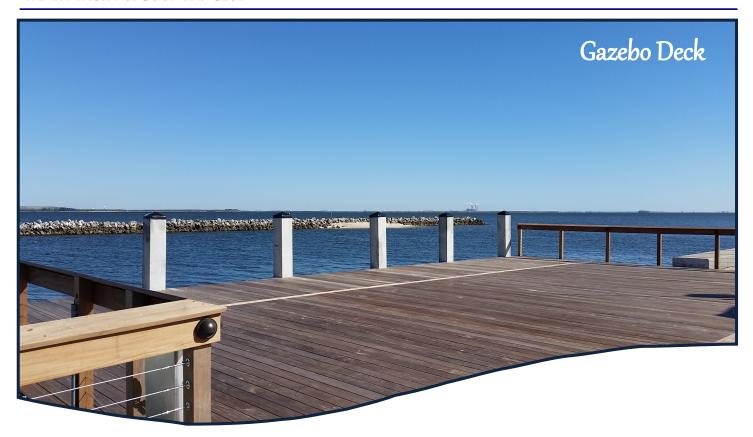
The **gazebo deck** on the north side of the marina entrance was also chosen to be IPE. This creates a large, beautiful wood surface for Club functions on an expansive bayfront deck. Concrete pilings were used in this location due to its exposure by Tampa Bay.

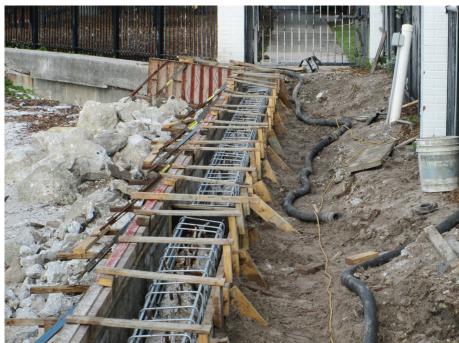
Forming the new seawall cap.

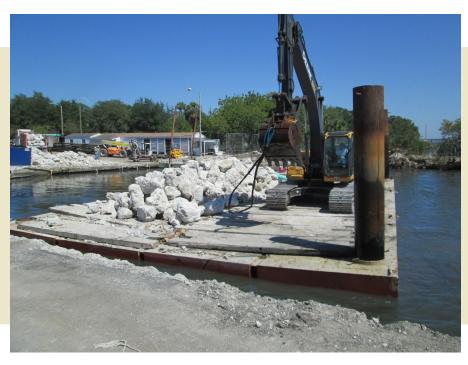
Loading breakwater rock on a barge from shore.

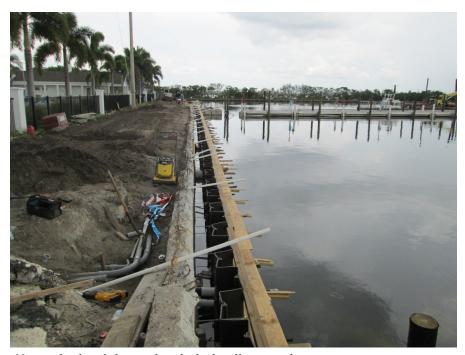
New tie back rods being placed which will tie into the concrete cap to support the wall.

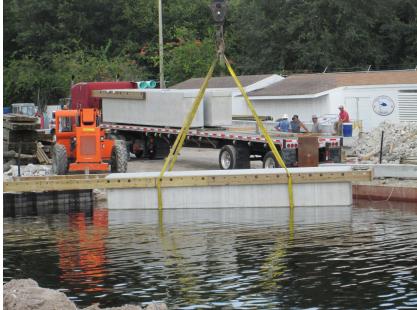
Concrete floating docks being unloaded and "splashed."

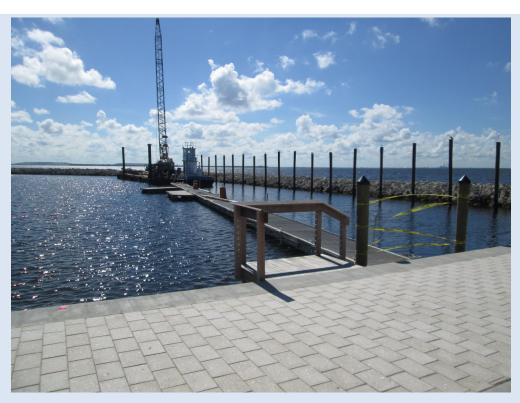
Temporary floating dock and F Dock pile installation.

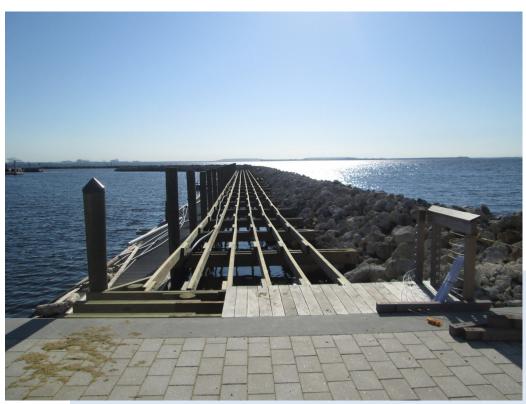
Dock framing in progress on F Dock.

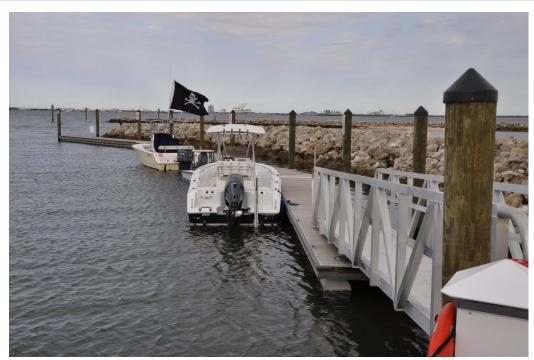
F Dock floating system.
