TIN CITY

WATERFRONT RESTORATION AFTER HURRICANE IRMA

by Todd Turrell

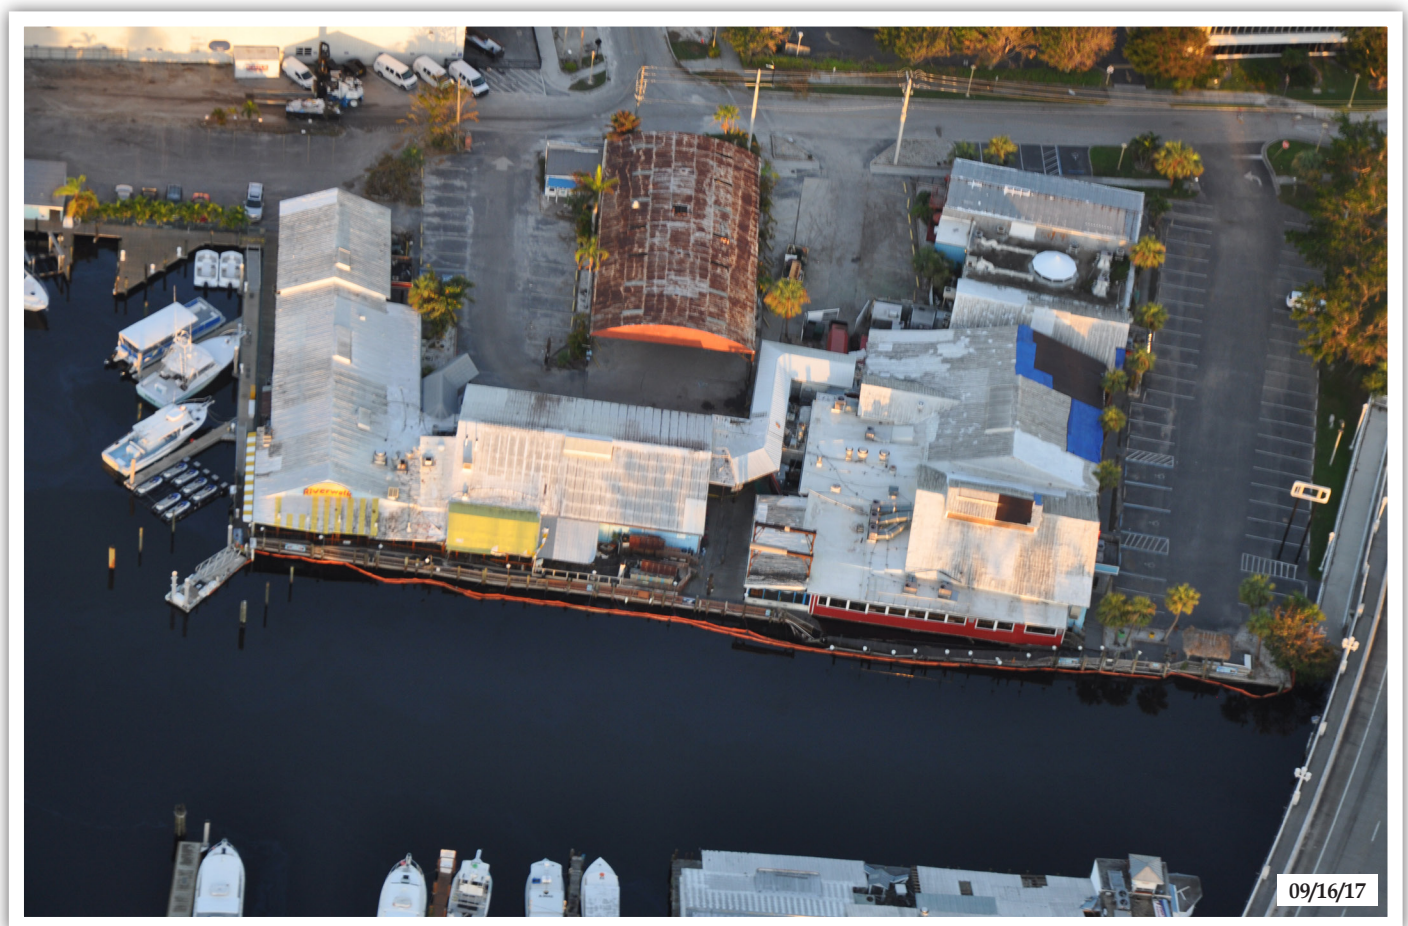
Aerial view of Tin City six days after the storm impacted the area. The orange line along the shoreline was a floating turbidity curtain used to contain debris from the damaged boardwalk area.

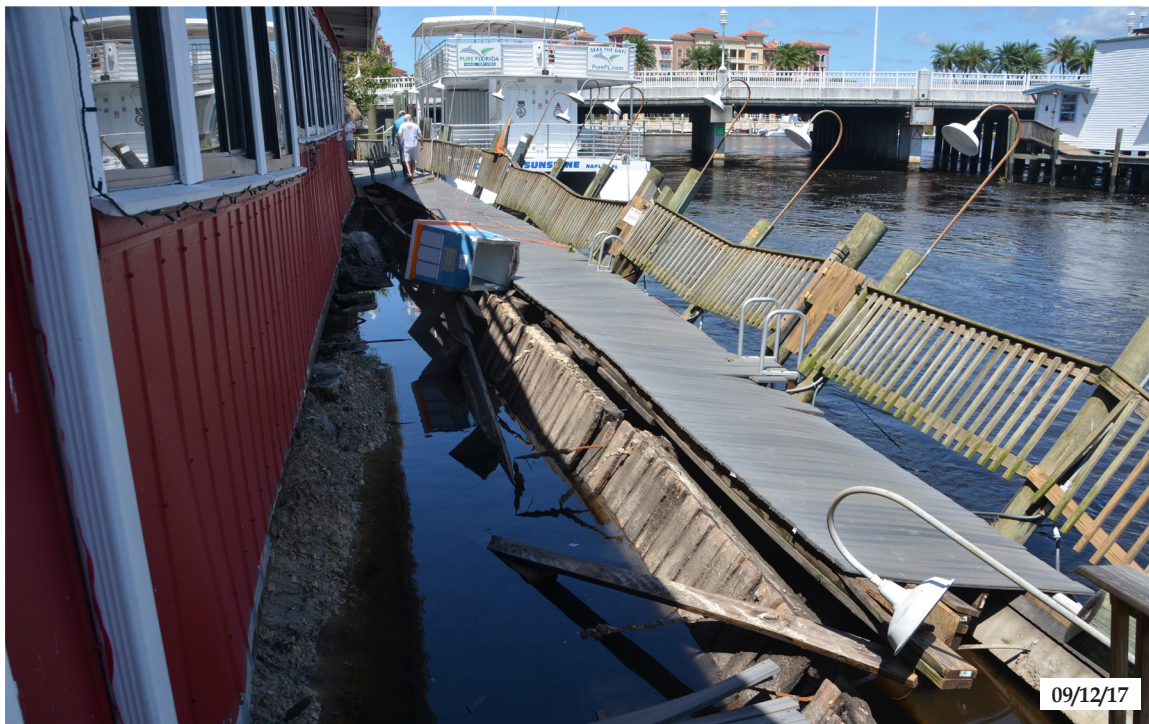
Damage to Tin City in front of Pinchers Restaurant two days after Hurricane Irma impacted the area.

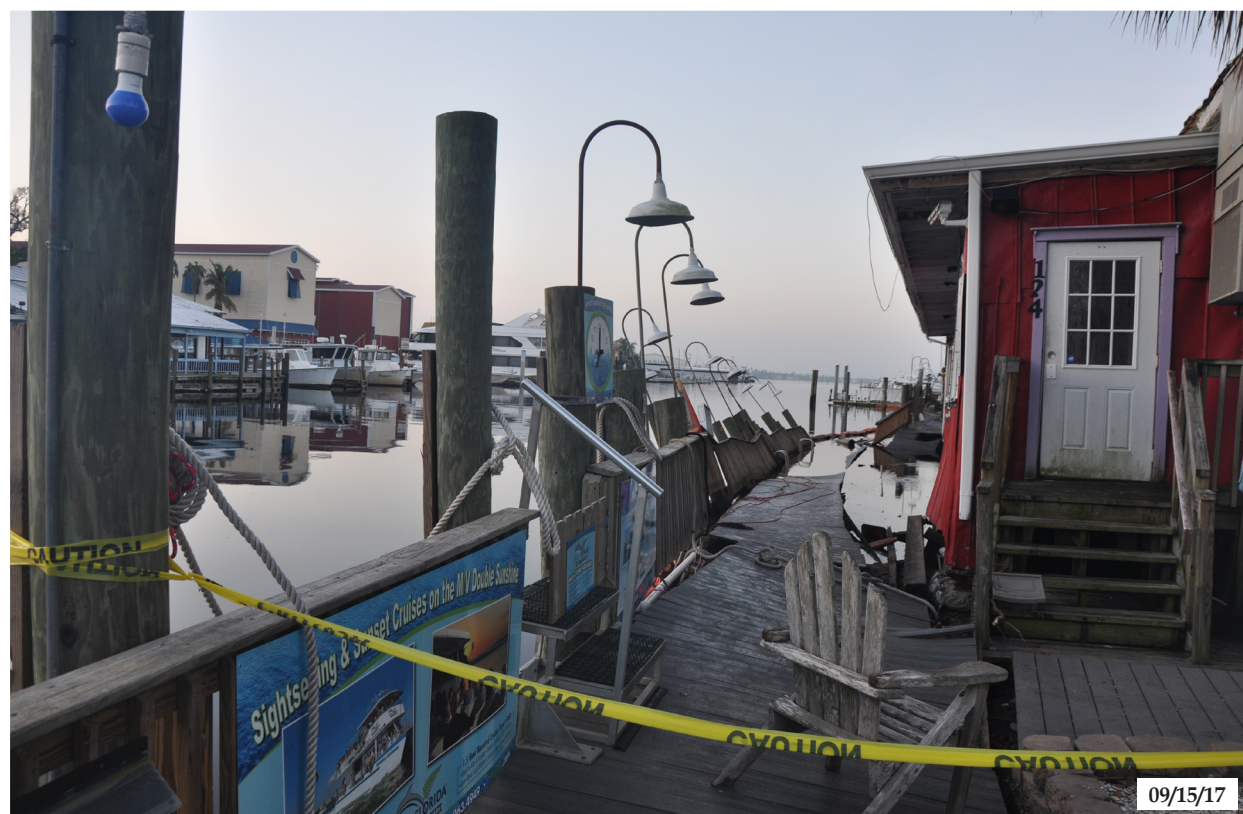
Looking south down the failed seawall and boardwalk.

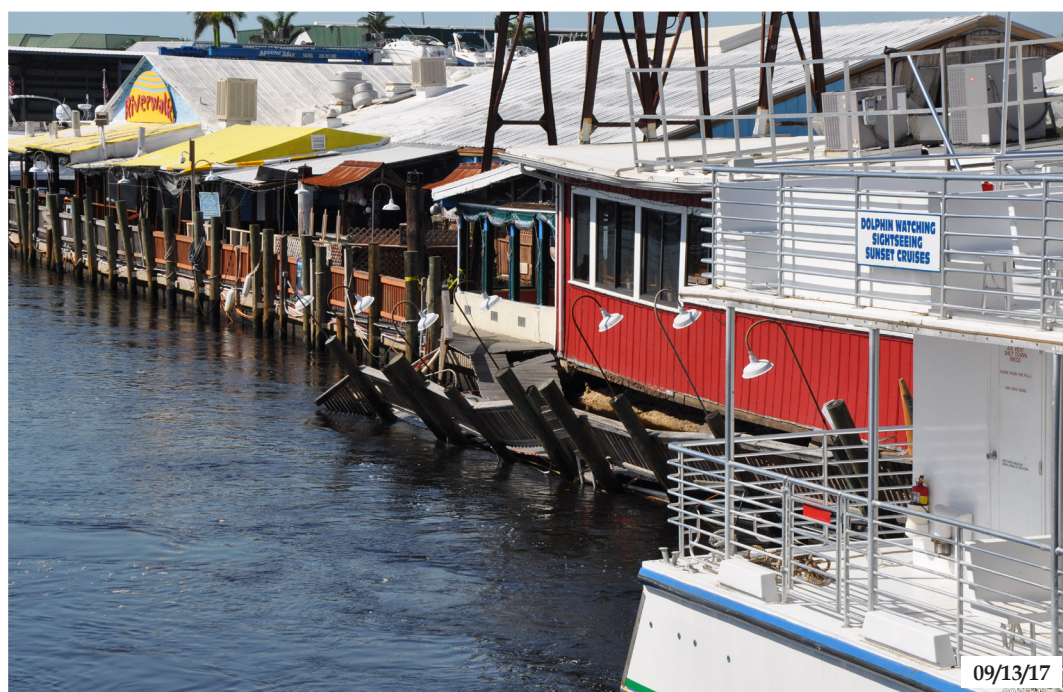
A view from atop the U.S. 41 bridge.

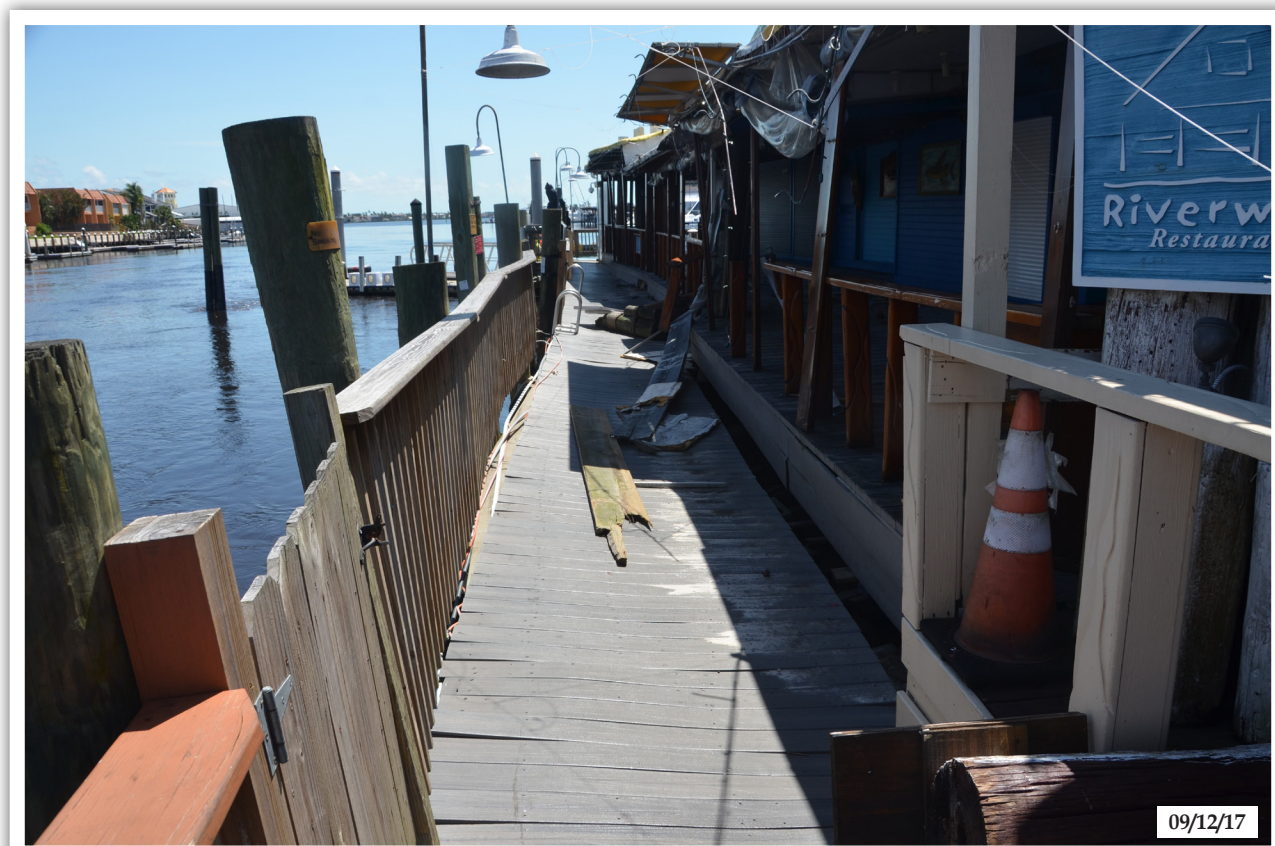
The damaged boardwalk in front of Riverwalk at the southern end of Tin City.

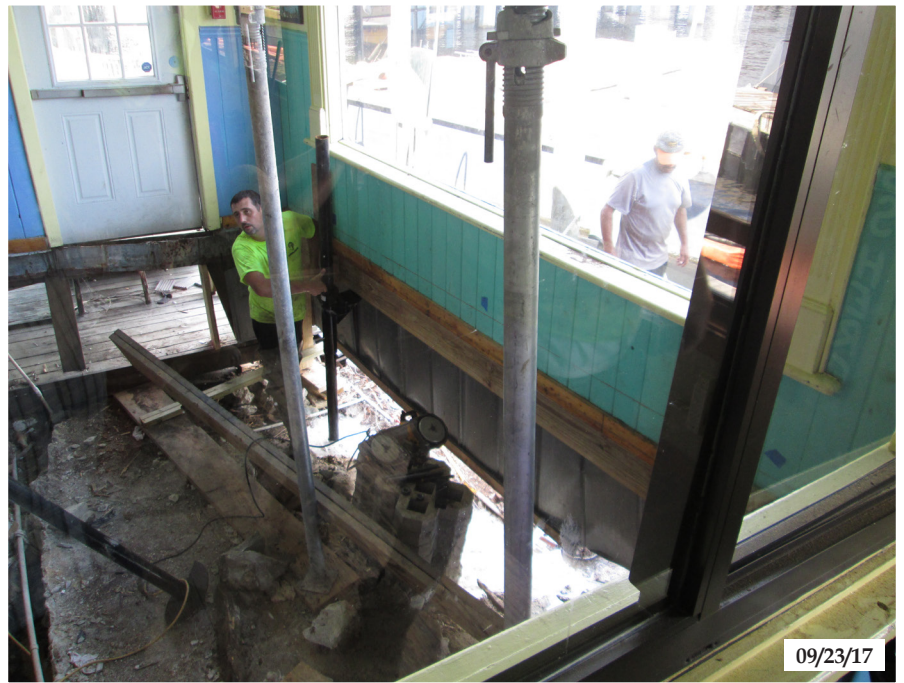
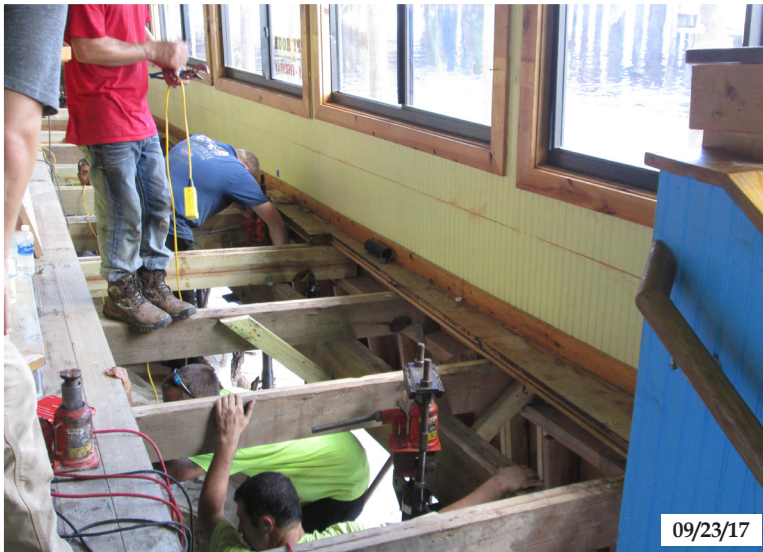
New sub-floor framing with screw jacks attached to lift Pinchers restaurant deck back up.

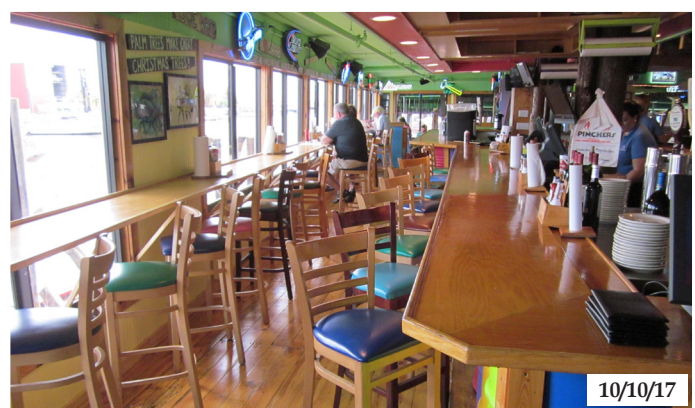
The bar floor at Pinchers after the floor boards were put back in place once repairs were complete.

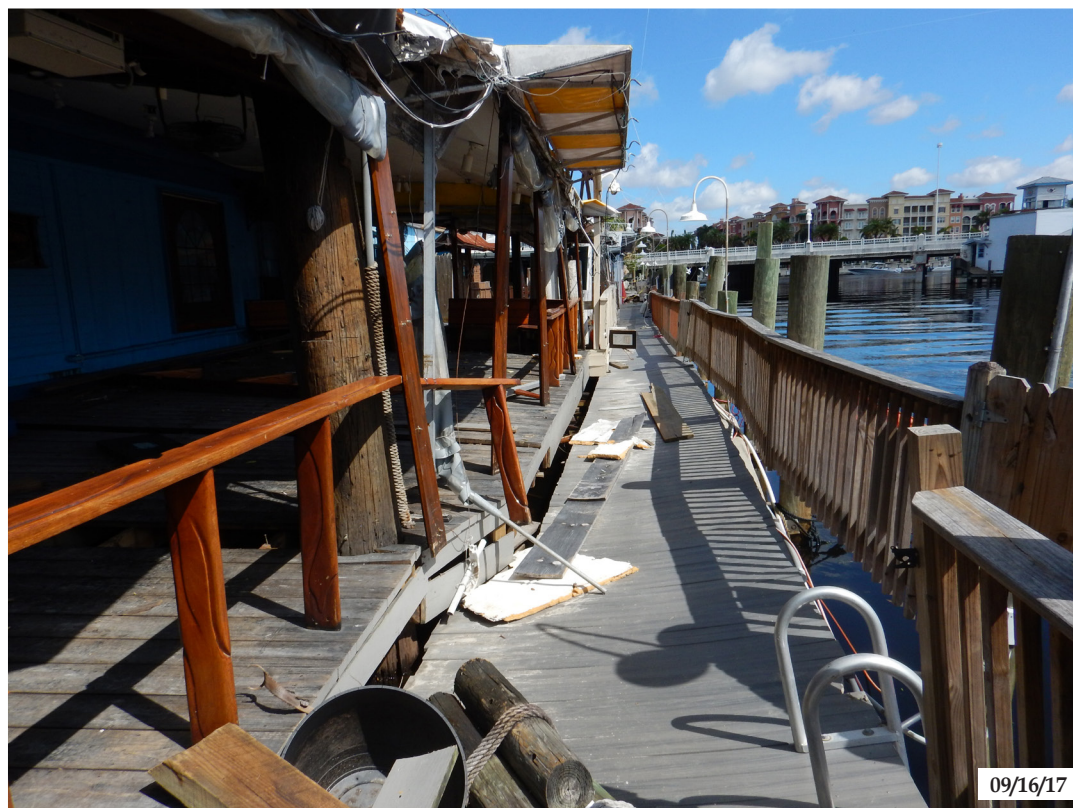
Damage from the hurricane shown in front of Riverwalk looking north towards U.S. 41.

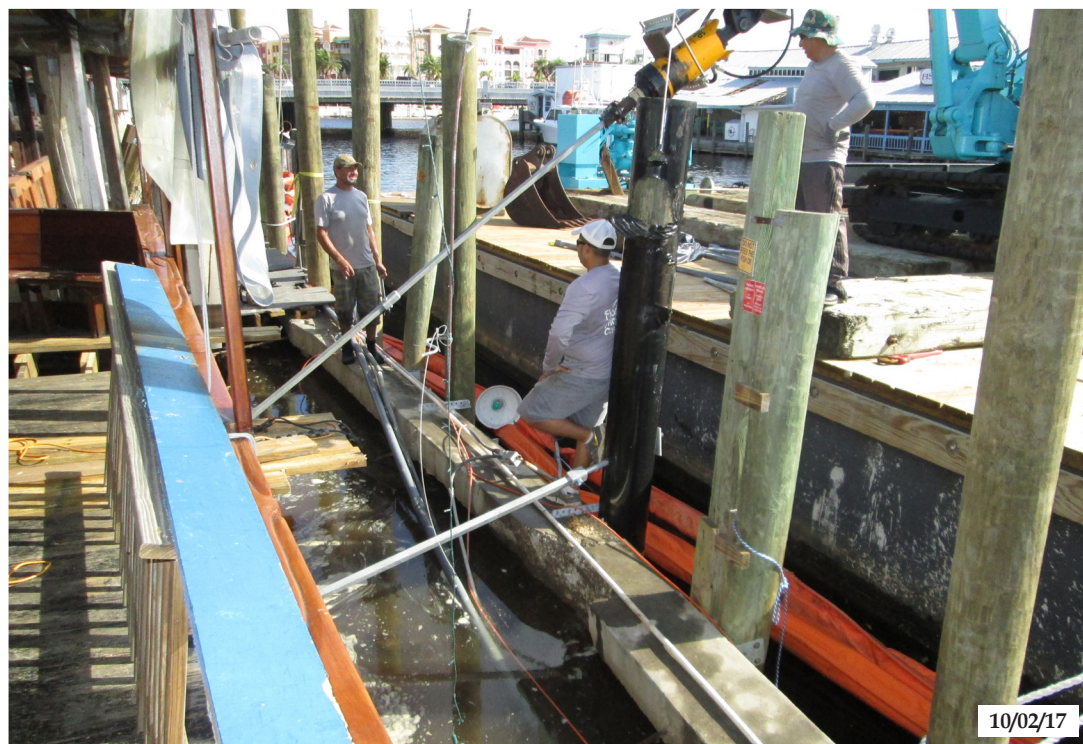
Installing steel helical tiebacks connected through the new seawall stabilization piles at Riverwalk.

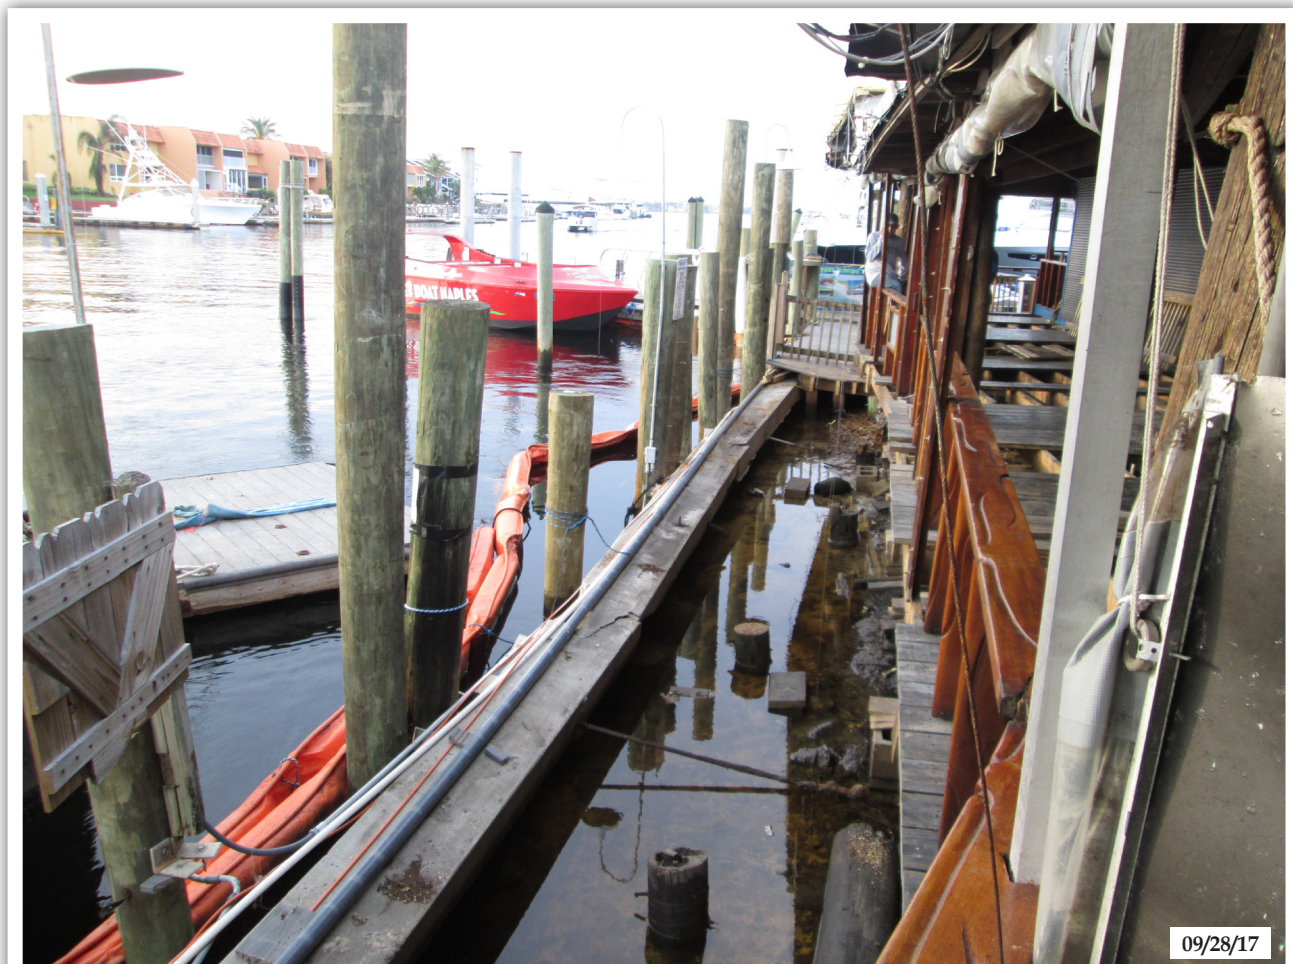
Riverwalk seawall stabilization piles.

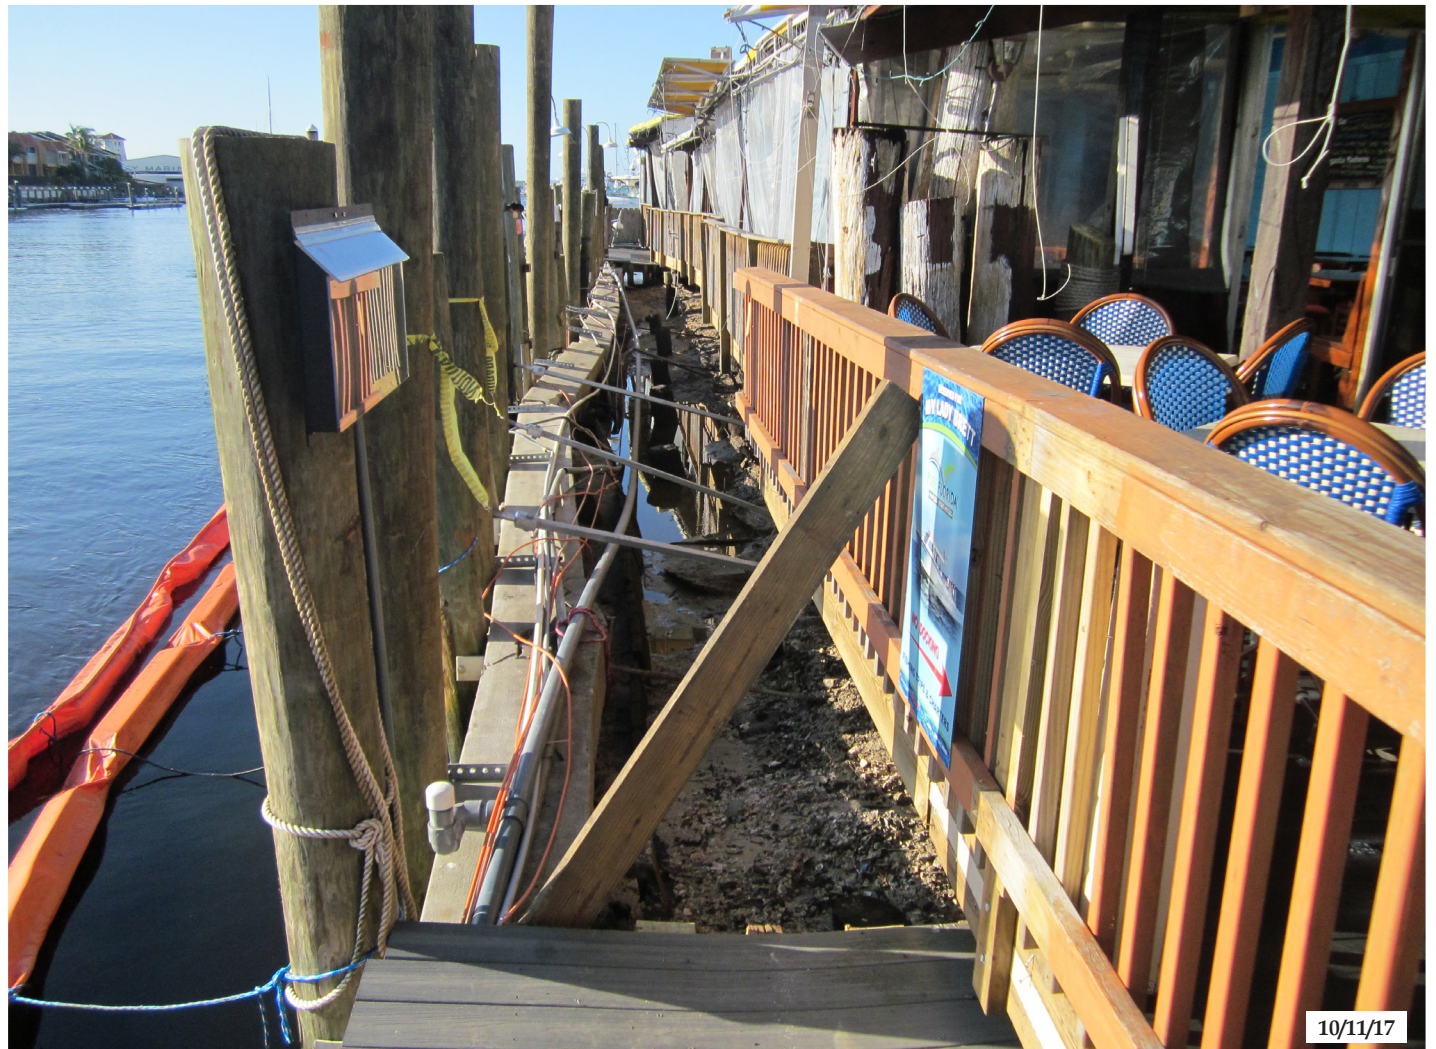
Riverwalk seawall stabilization pilings in place looking south.

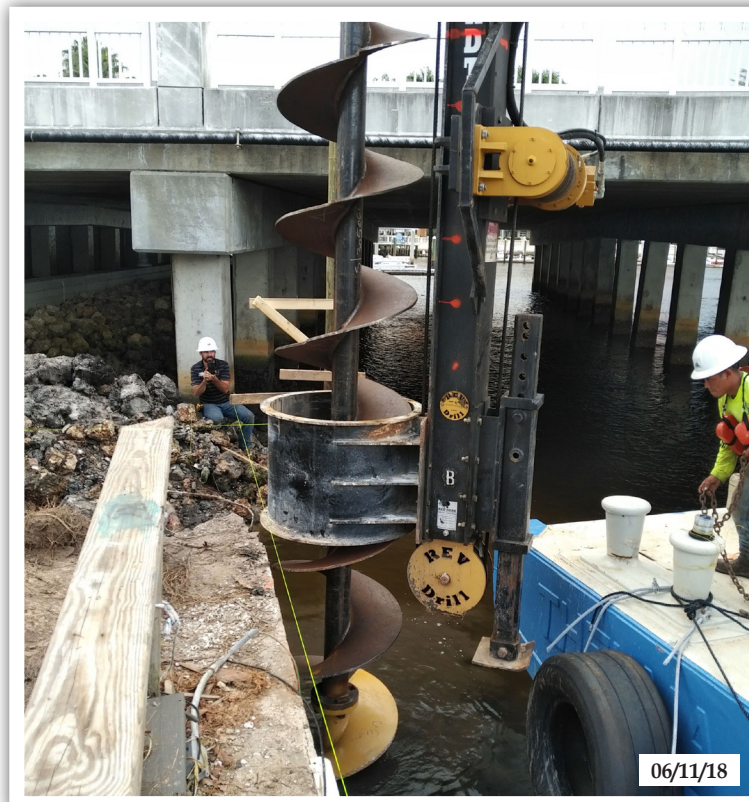
Drilling for steel H-piles to support the new wall.

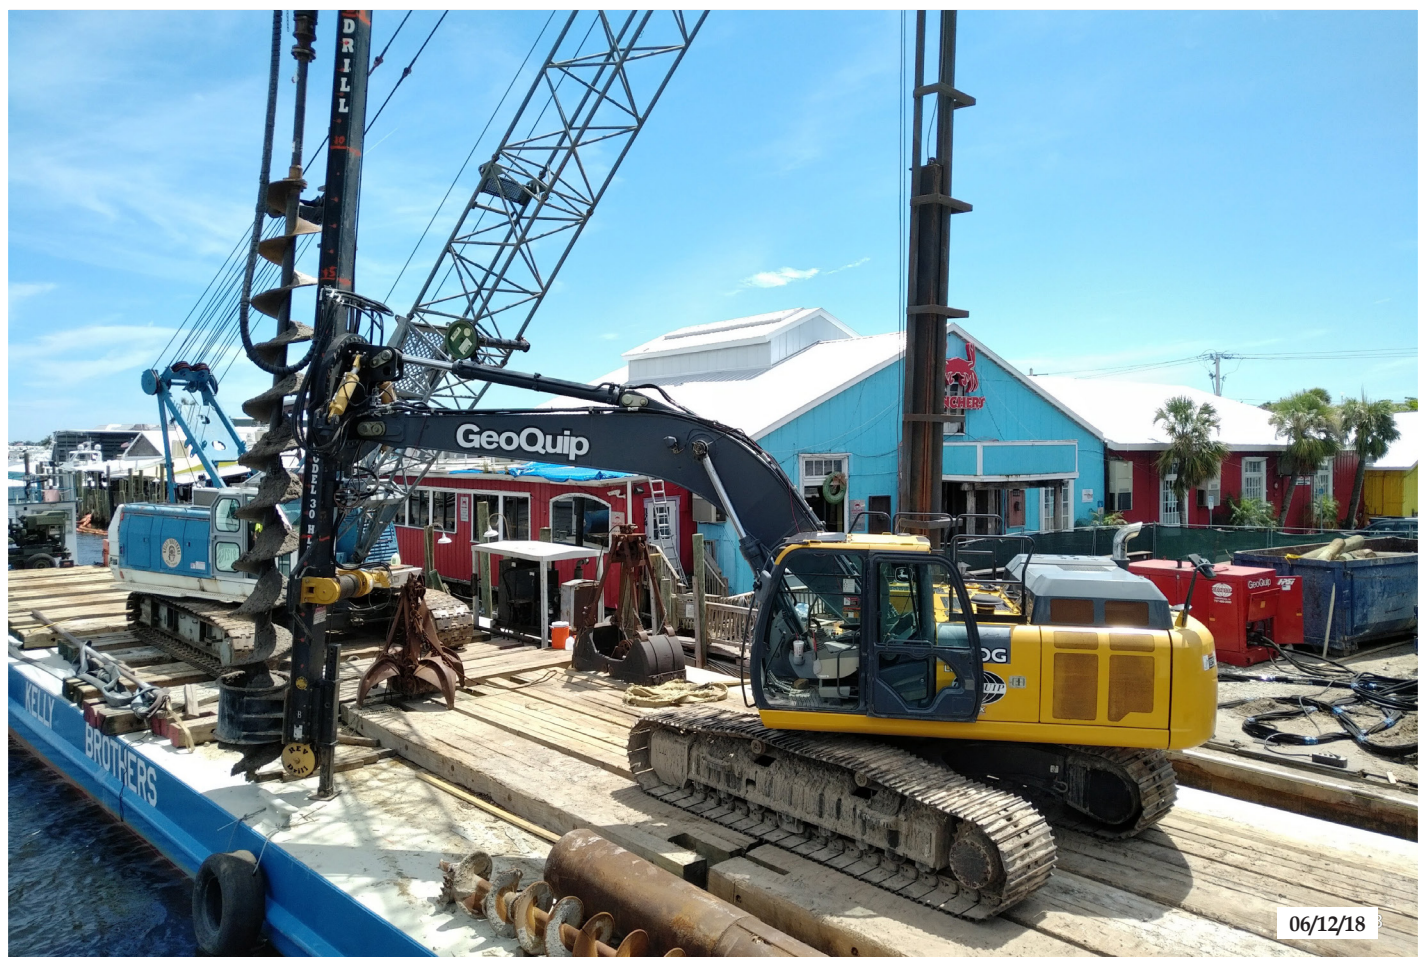
Drilling equipment for steel H-piles, drill to left.

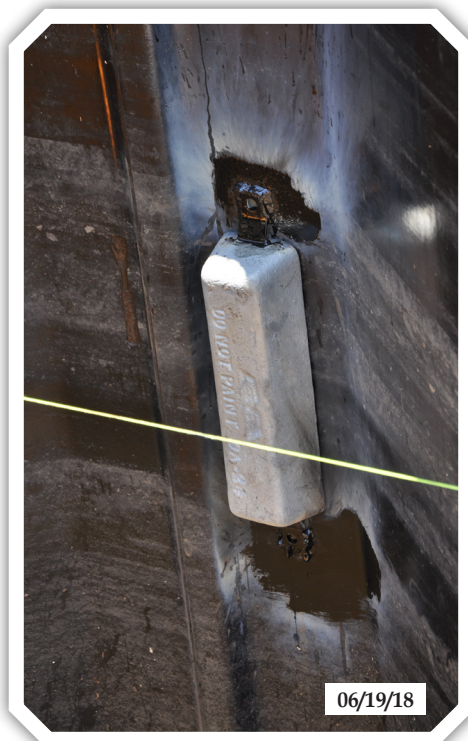
Zinc anode welded on steel sheet pile below the water line for corrosion control.

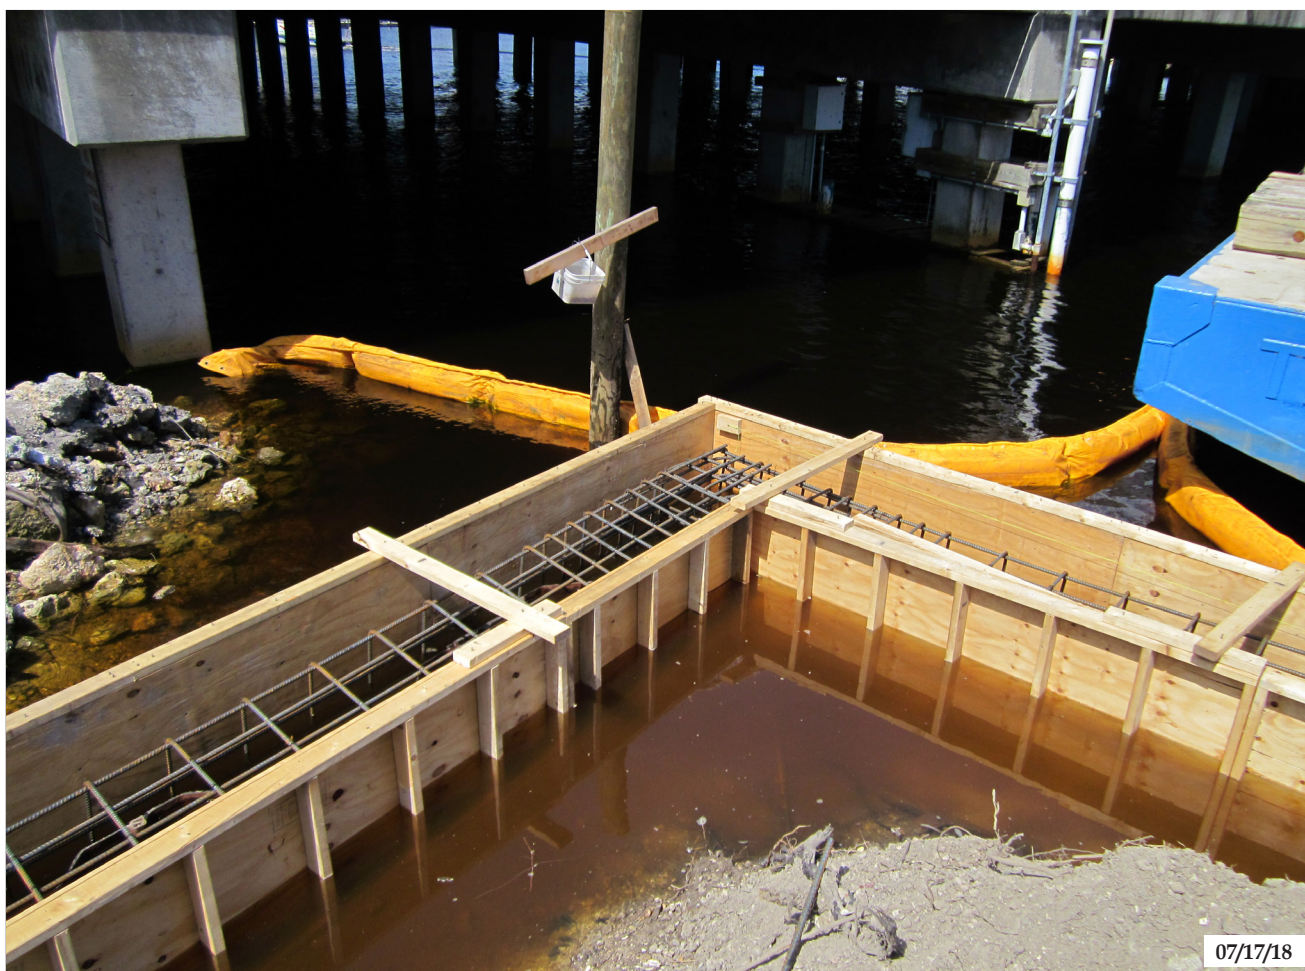
Seawall cap form with steel in place next to U.S. 41 bridge.

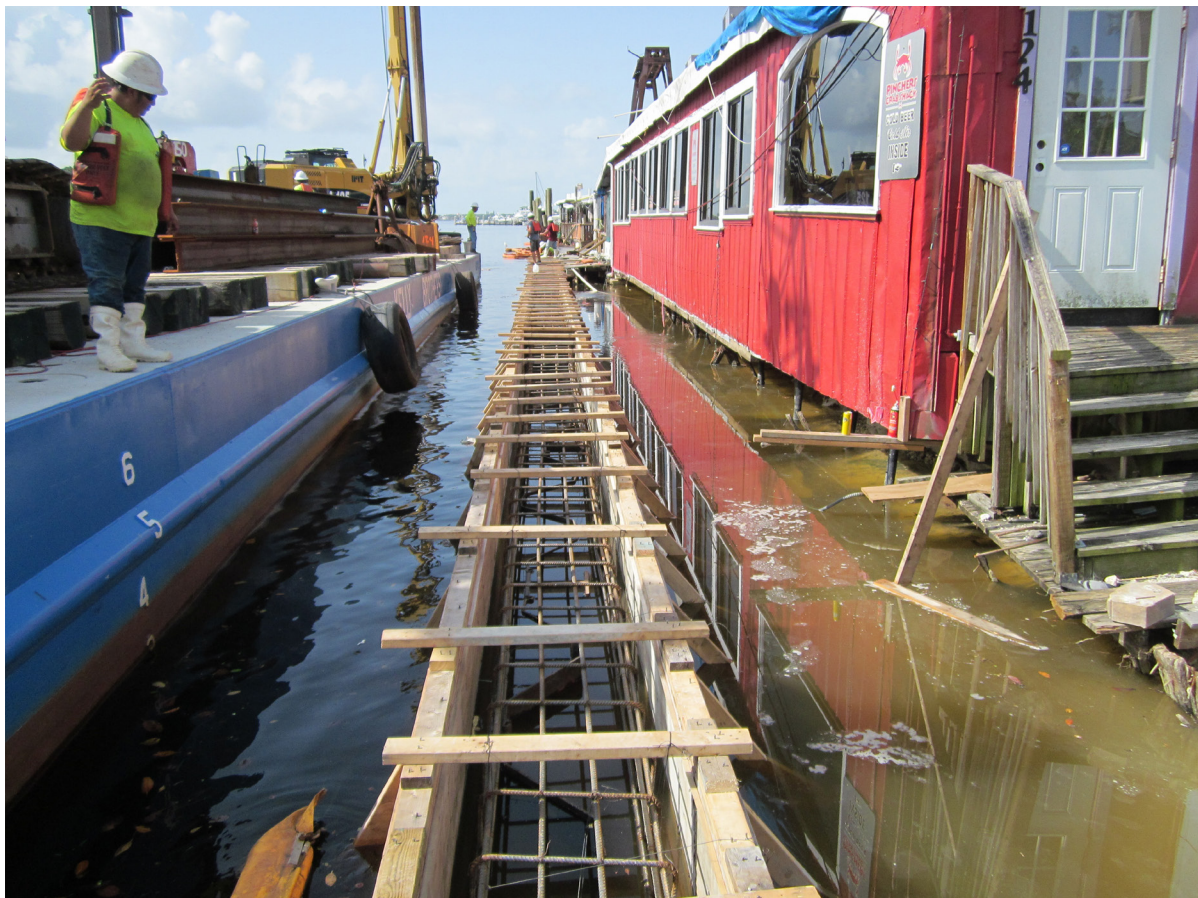
Seawall cap formed with steel reinforcement ready for concrete to be poured in front of Pinchers.

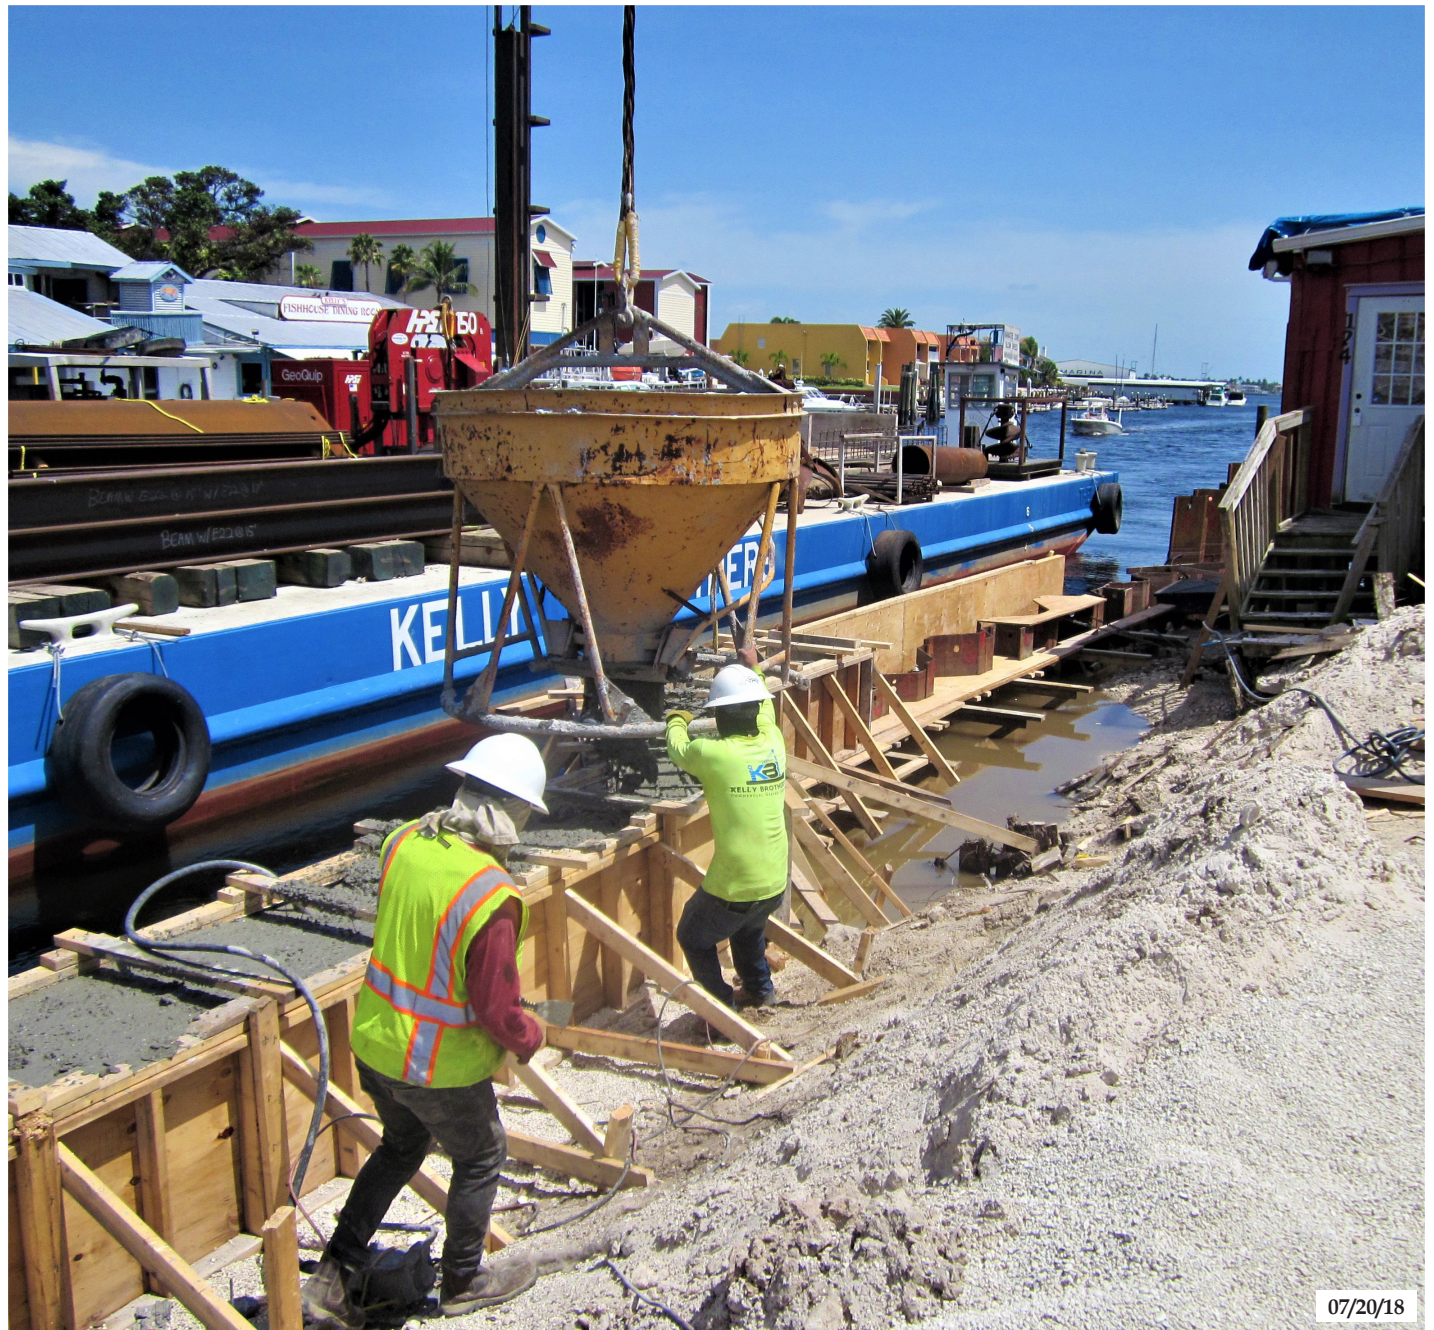
Pouring concrete into the seawall cap form.

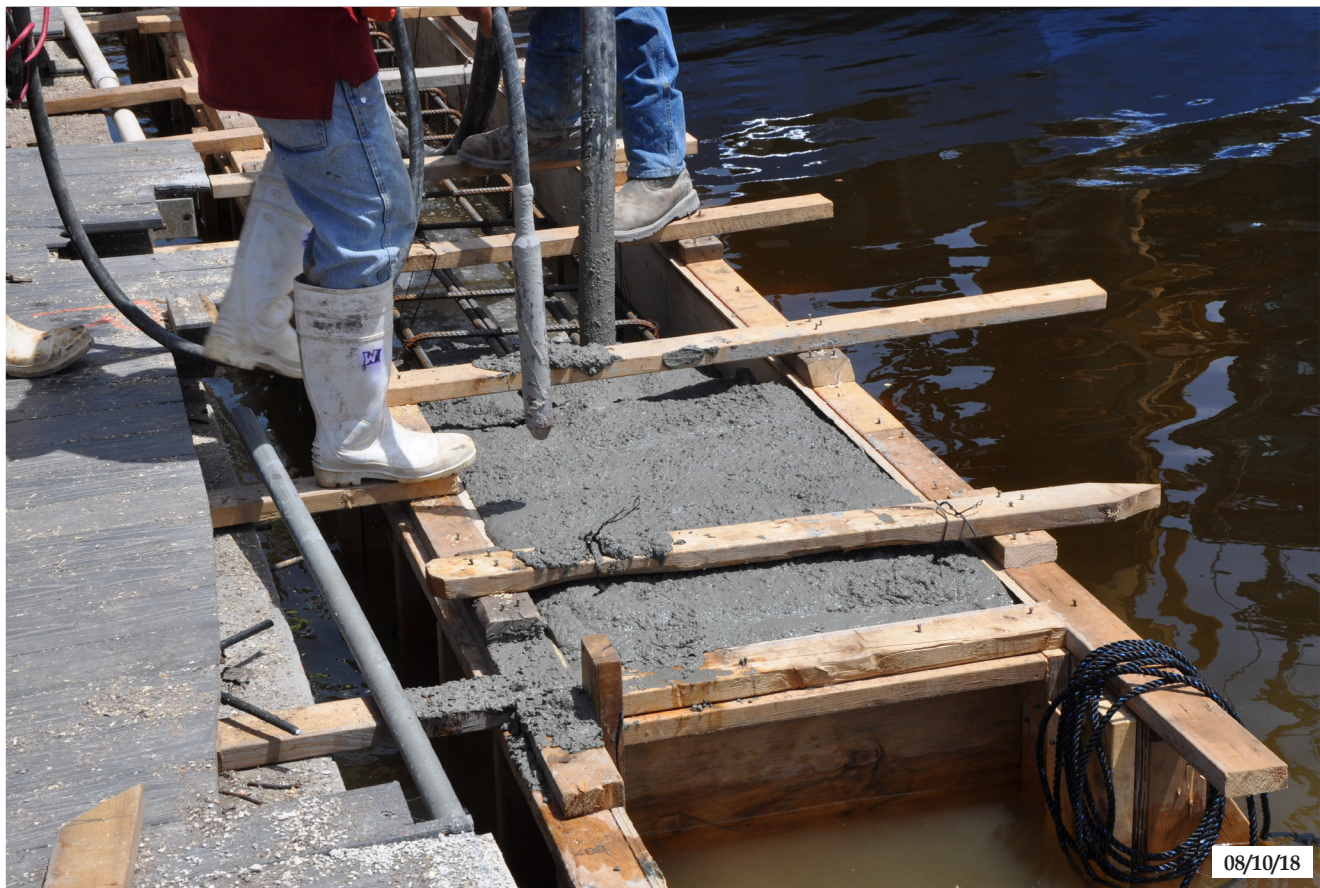
Concrete being vibrated into seawall cap form to prevent voids in the mixture.

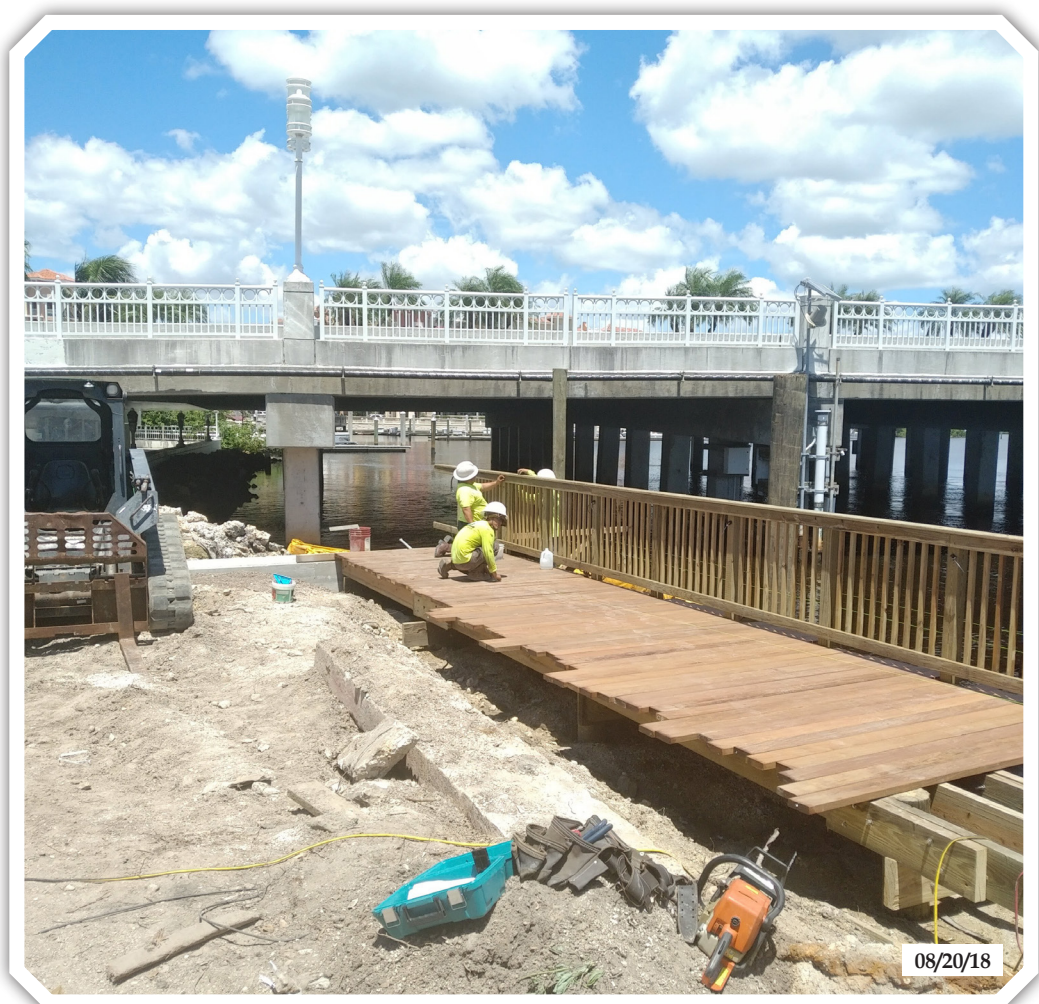
First section of new IPE boardwalk taking shape south of the U.S. 41 bridge.

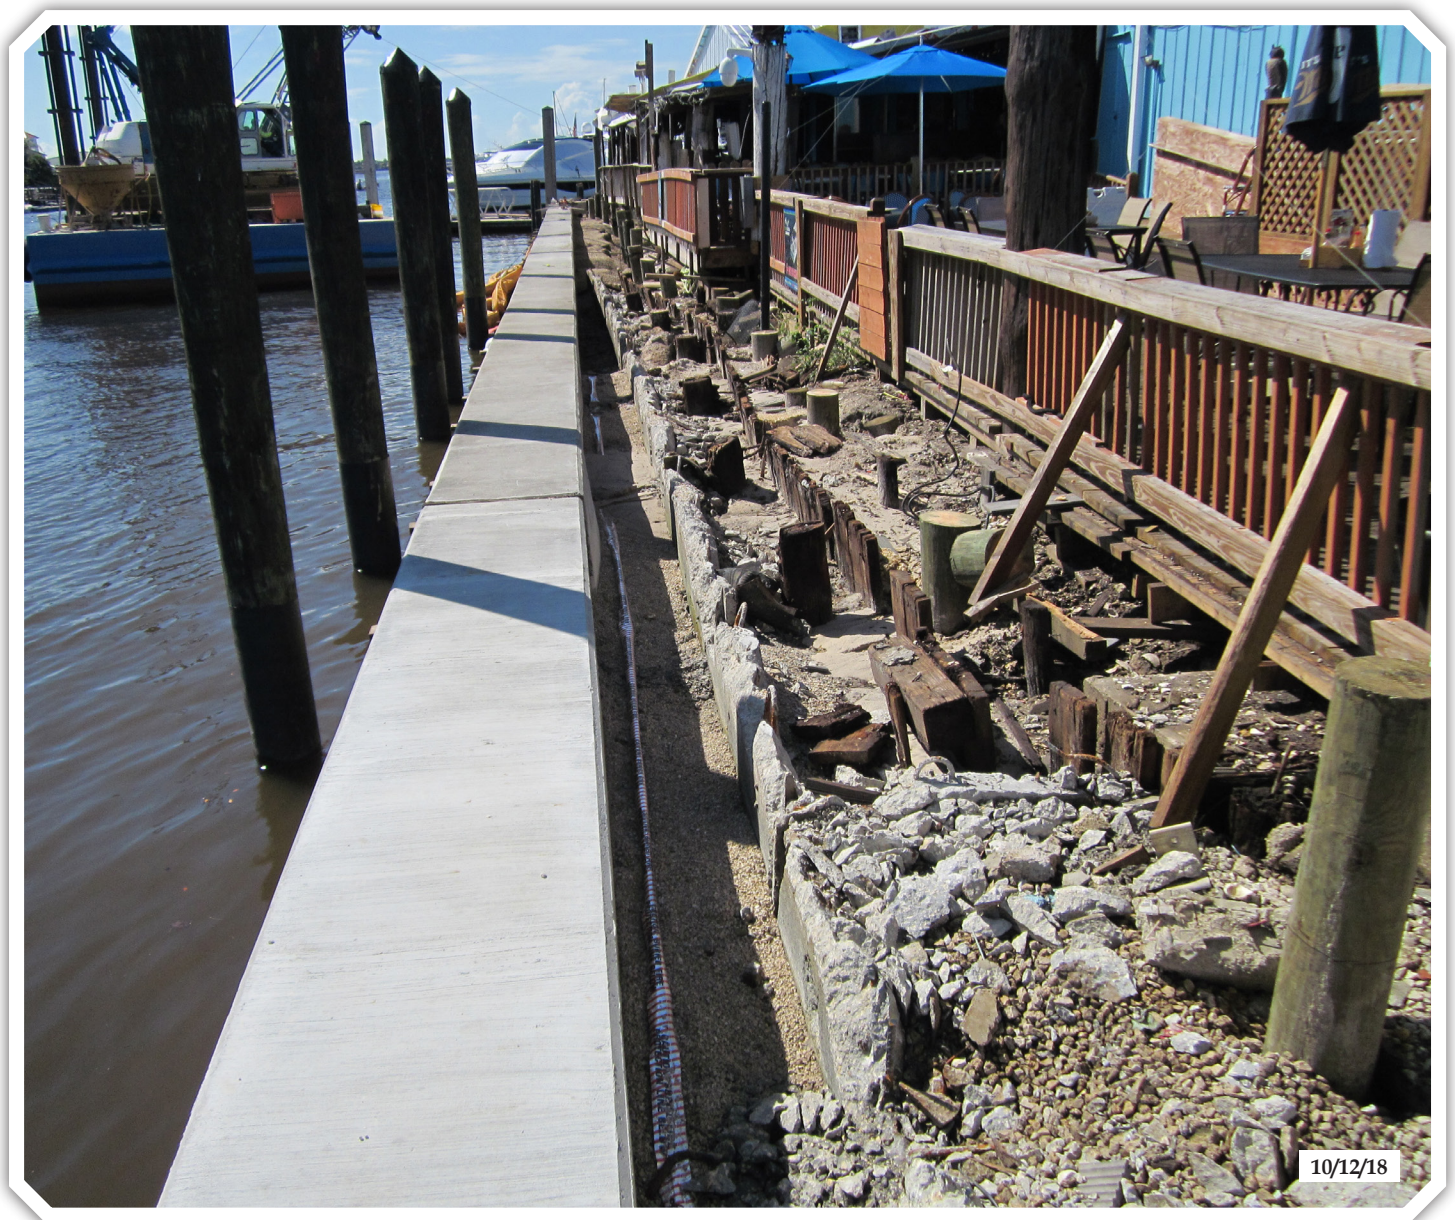
Old concrete wall, wood wall and debris prior to being entombed under new fill.

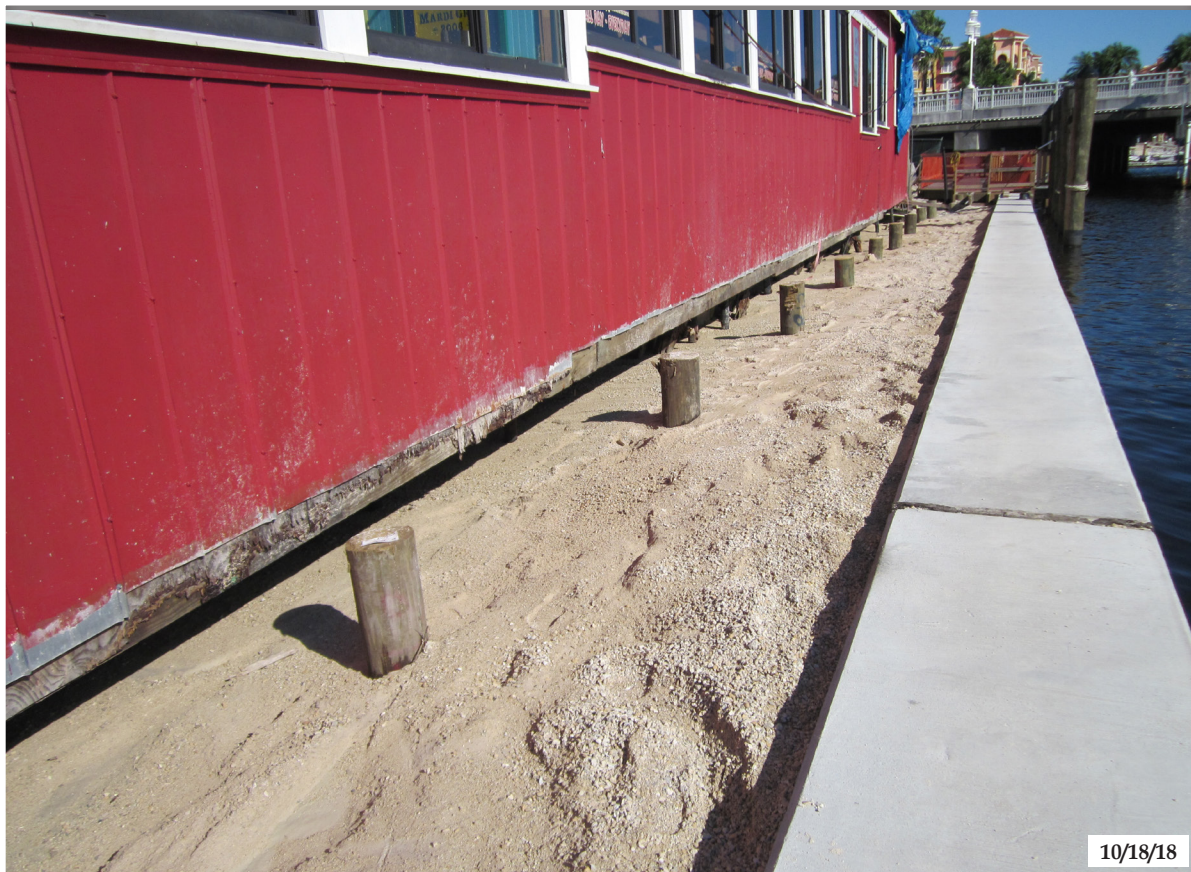
Boardwalk piles poking up from new fill after being driven deep underground.
