TIN CITY

WATERFRONT RESTORATION AFTER HURRICANE IRMA

by Todd Turrell

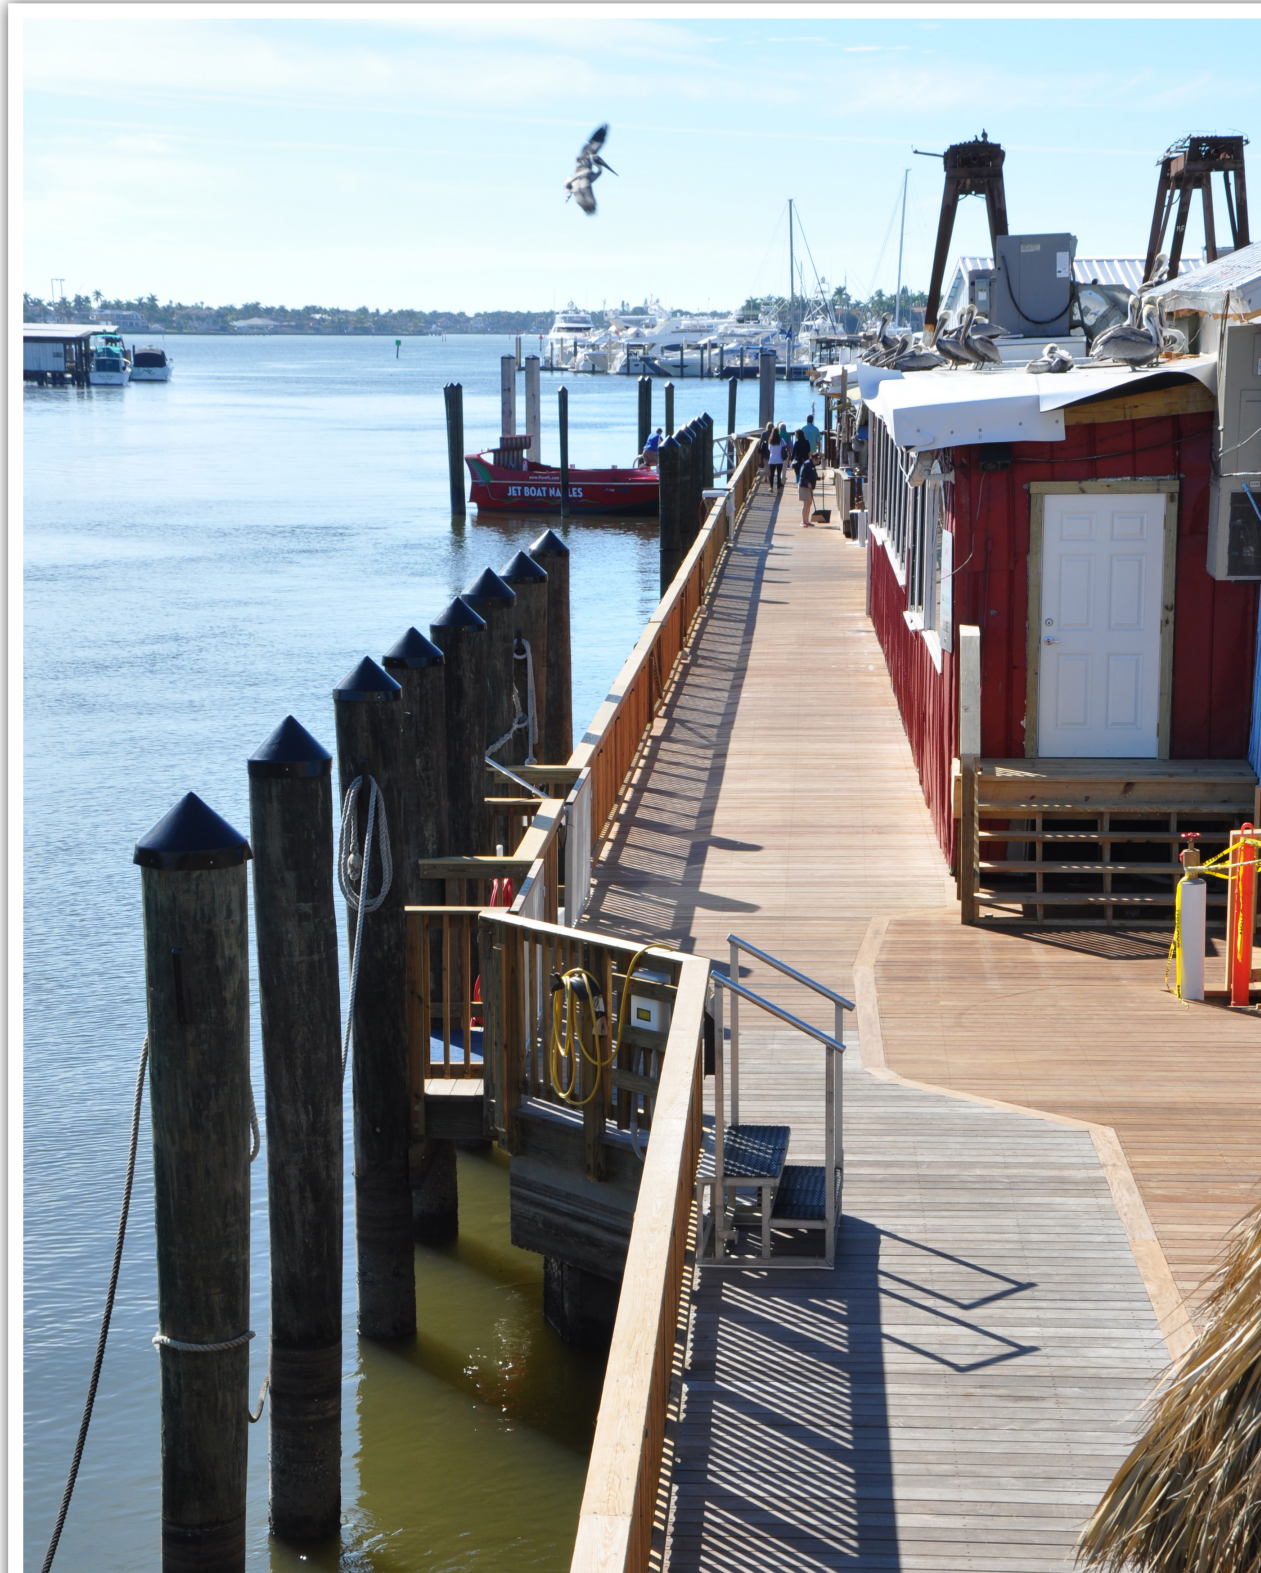
Tin City's new boardwalk sits atop the reconstructed seawall, ready for the 2018/2019 tourist season.
